DAMAGE SITUATION OF THE 12UD PELLETRON TANDEM ACCELERATOR AT THE UNIVERSITY OF TSUKUBA BY THE GREAT EAST JAPAN EARTHQUAKE

Kimikazu Sasa[#], UTTAC, University of Tsukuba, Tsukuba, Japan

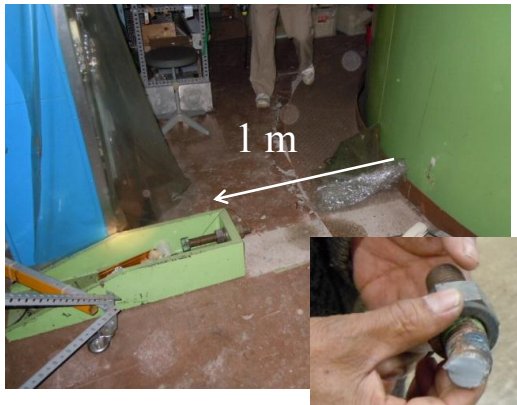
The accelerator tank was strongly shaken by the shock of the earthquake. Three shock prevention devices for the accelerator tank at the 7th floor were pushed out with breaking anchor bolts of 1 inch in diameter as shown in Fig. 3. Weight supports and jacks at the 4th floor were moved as nearly taken off as shown in Fig. 4. All high voltage accelerating columns fell down in the accelerator tank. Fig. 5 shows the downed accelerating column in the tank at the bottom. Structures of the terminal shell and columns inside the tank were completely collapsed.

Figure 3: Broken shock prevention device for the accelerator tank at the 7th floor. Anchor bolts of 1 inch in diameter for the shock prevention device were severed by the shock of the earthquake.

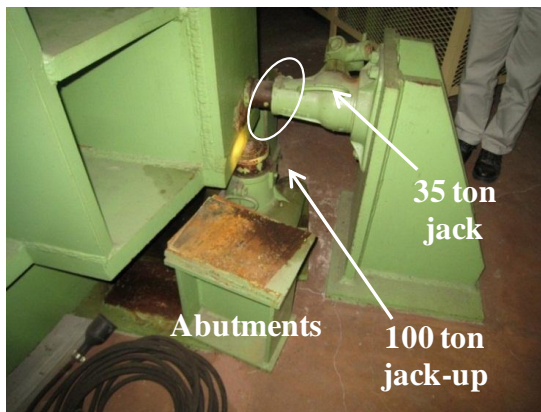
Figure 4: Moved weight supports and jacks at the 4th floor by the shock of the earthquake.

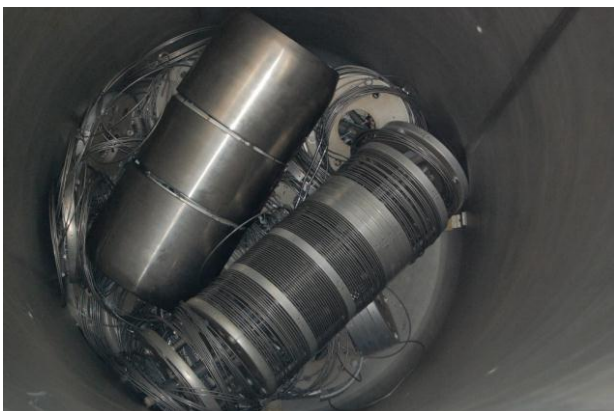
Figure 5: Collapsed accelerating column and terminal (the view from the 7th floor).

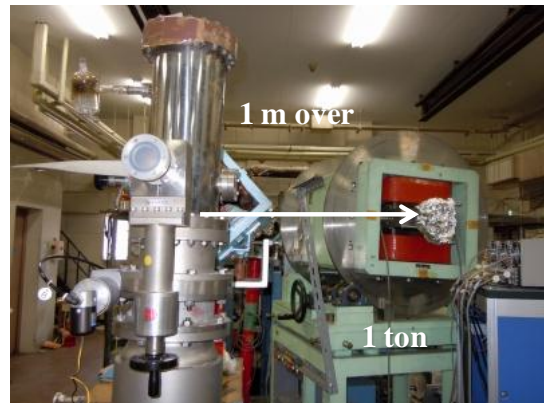
Two of three ion sources at the 9th floor were also seriously damaged by the earthquake. The anchor bolts of the Wien filter for the polarized ion source were destroyed by the earthquake. Finally, the Wien filter was moved 1 m

Figure 6: Broken Wien filter for the polarized ion source. The Wien filter was moved 1 m from the beam line after the earthquake and aftershocks.

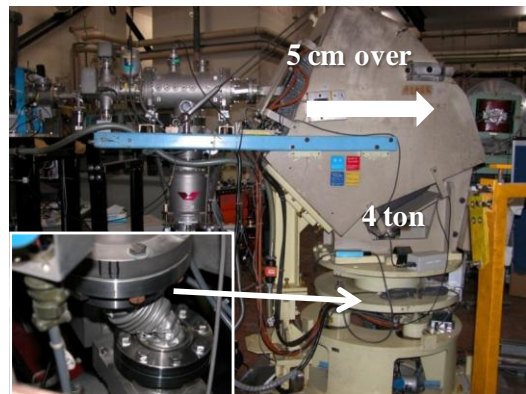
from the beam line by the earthquake and aftershocks for a month as shown in Fig. 6. Almost piping bellows between connected heavy loads were broken by shaking at the 9th floor. Ceramic columns of the AMS ion source were also broken. Water pressure gauges of the cooling water system were shaken and broken off by its root on the plumbing. A water spurt came out the polarized ion source. The inflection magnet weight of 4 tons at the 9th floor was moved 5 cm on the mount by the earthquake as shown in Fig. 7.

Figure 7: Moved inflection magnet at the 9th floor.

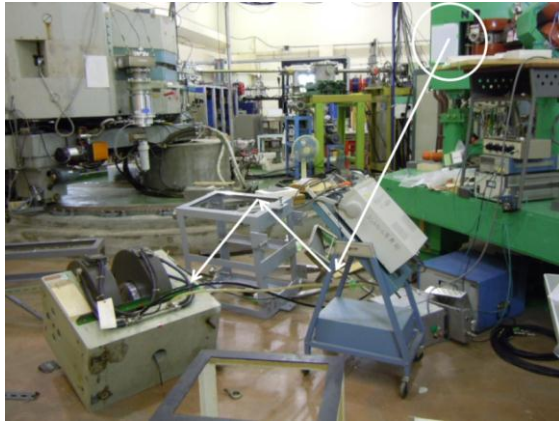
At the 1st floor, a β -NMR experimental magnet weight of 800 kg at the 1-F beam course was dropped from heights of 1.75 m with breaking a stepladder as shown in Fig. 8. Several tool racks also fell down in the facility (Fig. 9). Many magnets were moved and a number of joint bellows were broken as shown in Fig. 10. Many vacuum apparatuses such as turbo-molecular pumps and ion pumps were damaged at points around broken joint bellows. A shielding door motor was broken by the shock of the earthquake at the analyzer magnet room. Therefore, we could not access immediately in the analyzer magnet

Figure 8: Dropped β -NMR experimental magnet at the 1-F beam course of the 1st floor.

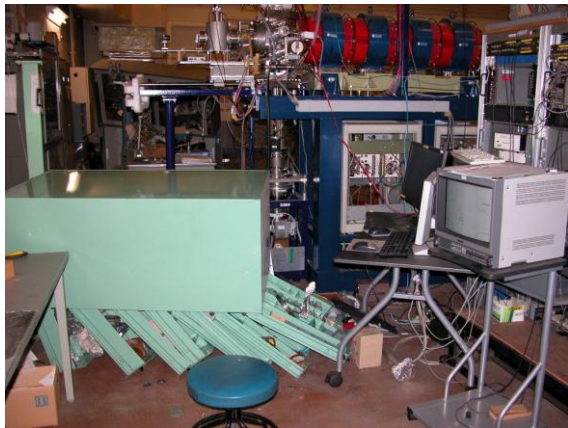
Figure 9: Fallen shelf at the 1-0° beam course.

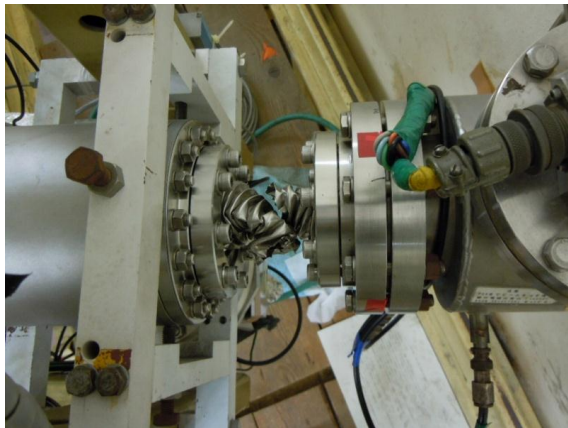
Figure 10: Broken joint bellows after the analyzer magnet of the 1st floor.
