DOE Role in Fukushima Response

Frank Moore
Aug 10, 2012

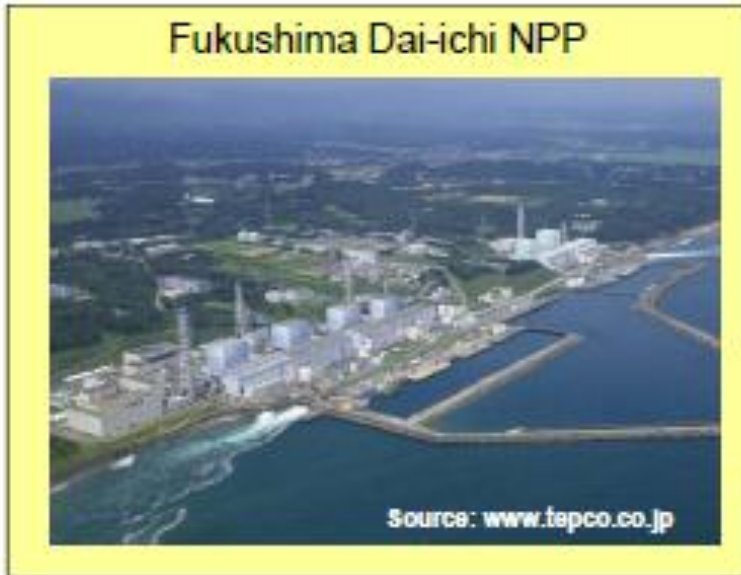
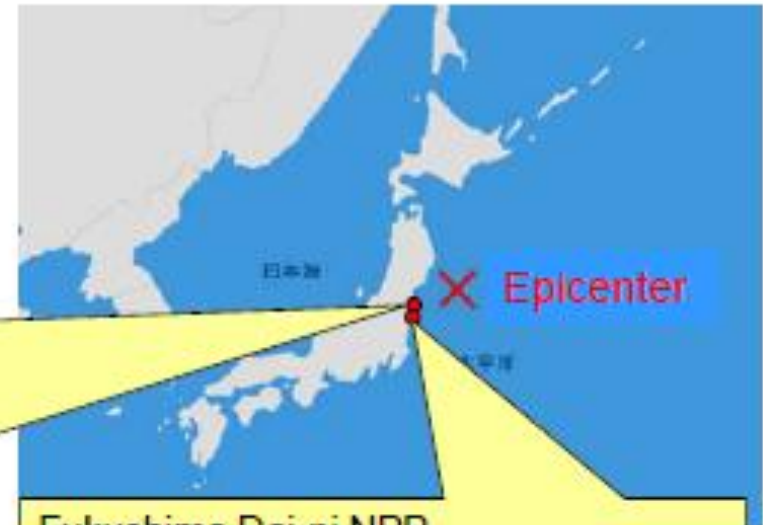
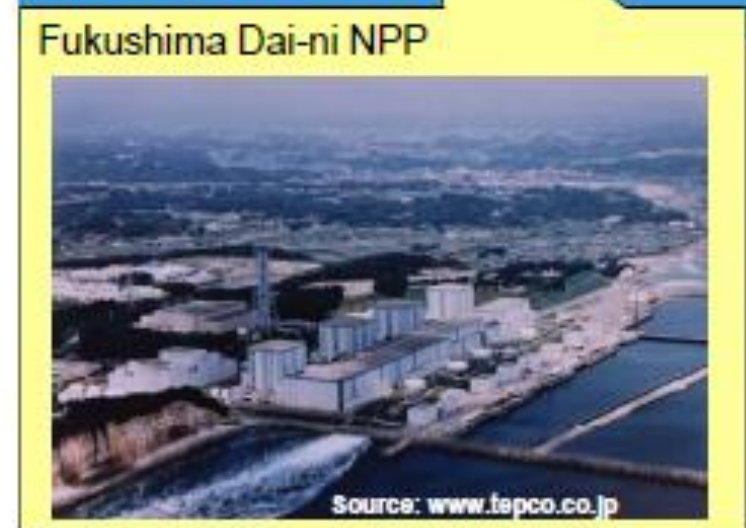
Statement of Problem

- Occurred 14:46 March 11, 2011
- Magnitude: 9.0 Mw
- Epicenter location: 38° 6" N and 142° 51" E, and 24km in depth
- It is said that the height of tsunami attacked Fukushima NPP was more than 14m

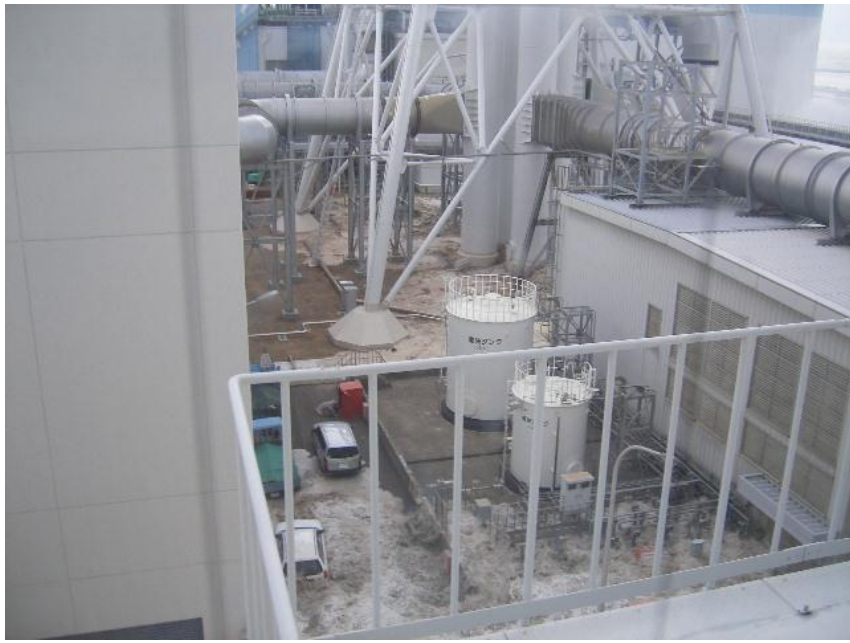
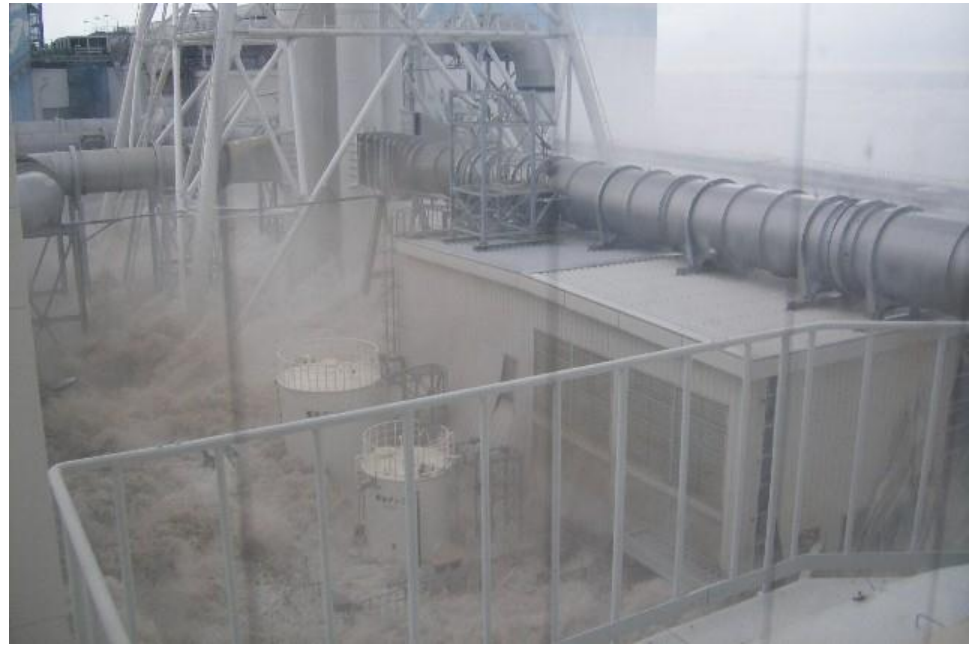
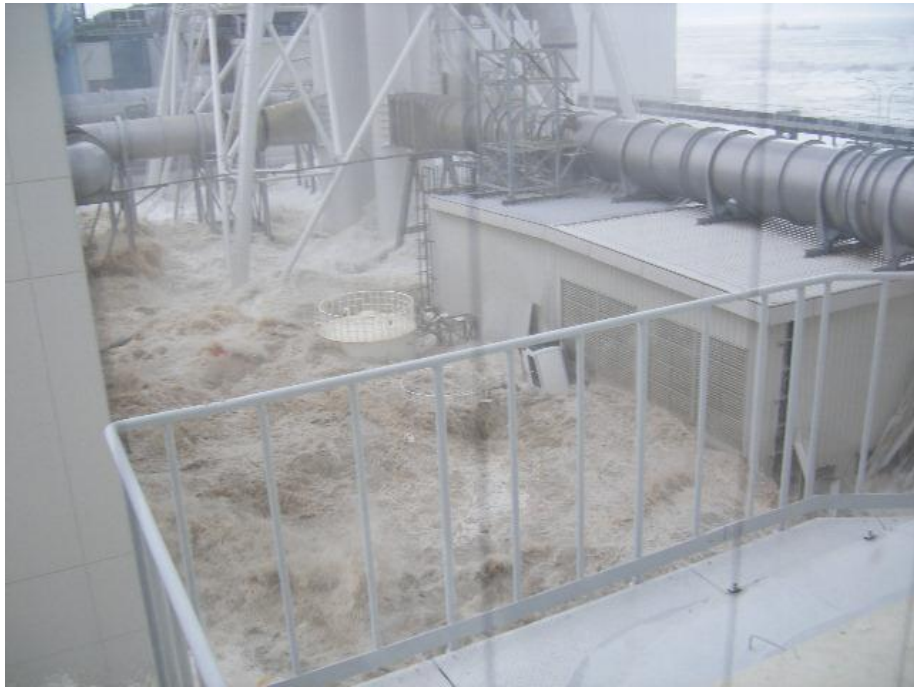
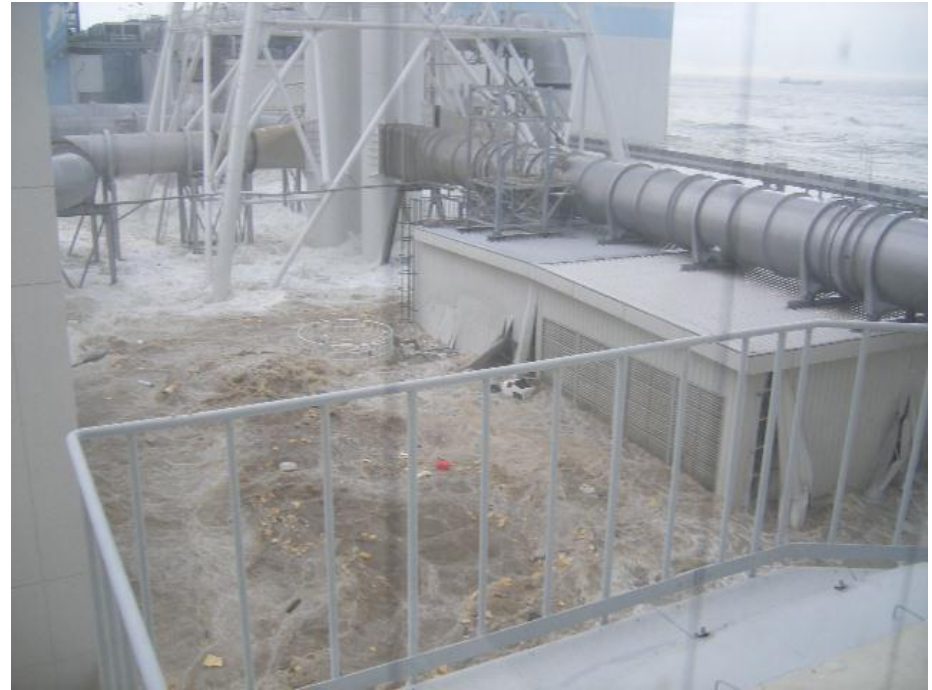
- After batteries ran dry, loss of core cooling led to coolant boil-down, uncovered fuel, decay heat buildup and fuel-rod degradation. Due to the lack of heat sink, the containments pressurized and **venting commenced**
- Zr cladding oxidation from exposed fuel lead to H₂ release that apparently found its way into the reactor buildings
- **Explosions (most likely H₂ detonations) in Units 1 and 3** occurred on 3/12 and 3/14, damaging the reactor building upper structure (not containment boundary).
- During these events, site personnel also struggled to keep the spent fuel pool ponds covered with water, particularly for Unit 4 that contained a full core off-load
 - **Explosion at unit 4 on 3/14, presumably H₂ detonation**
- Contaminated water leaks and deliberate water releases to ocean mid- to late March
- Multiple release scenarios and pathways to the environment

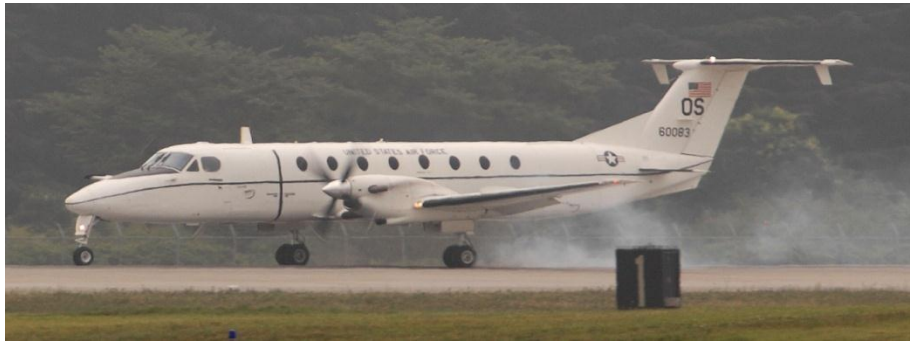
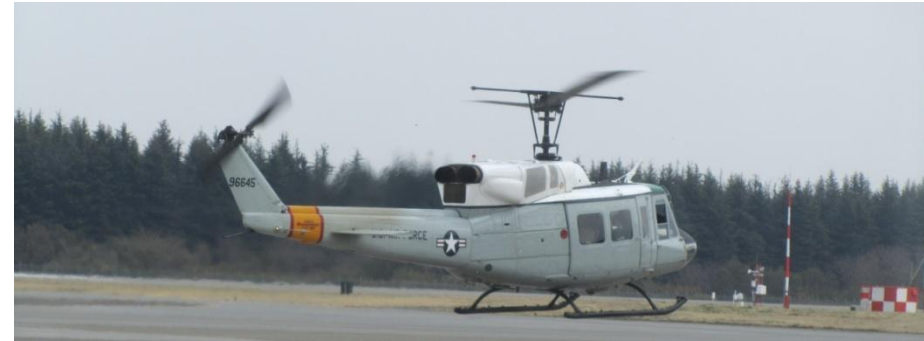
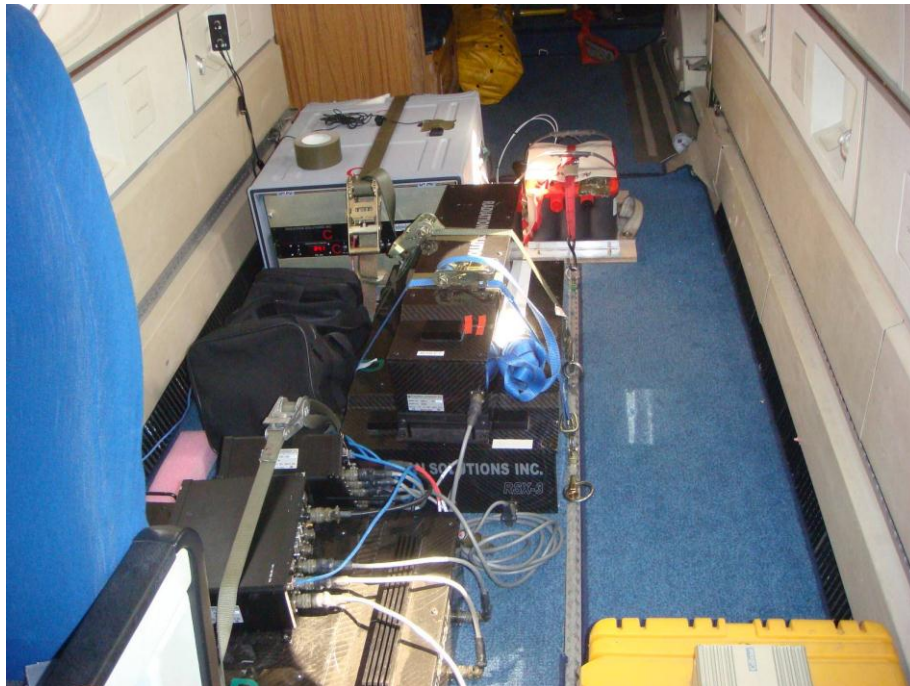
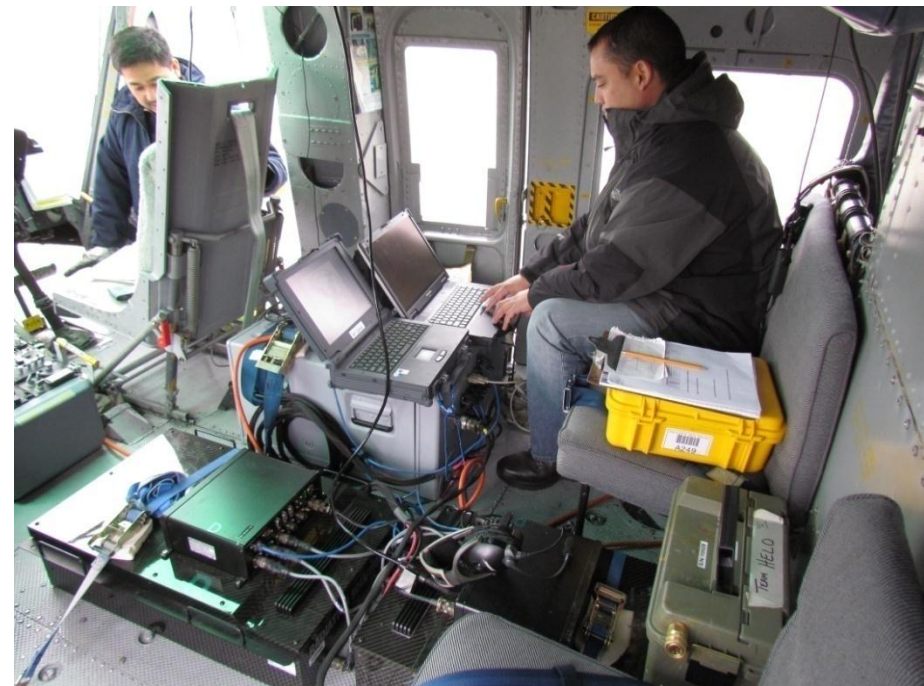
AMS on USAF Aircraft

- Fixed wing and helicopter
- Up to 3 aircraft per day
- Surveys over US bases
- Joint DOE & GOJ survey

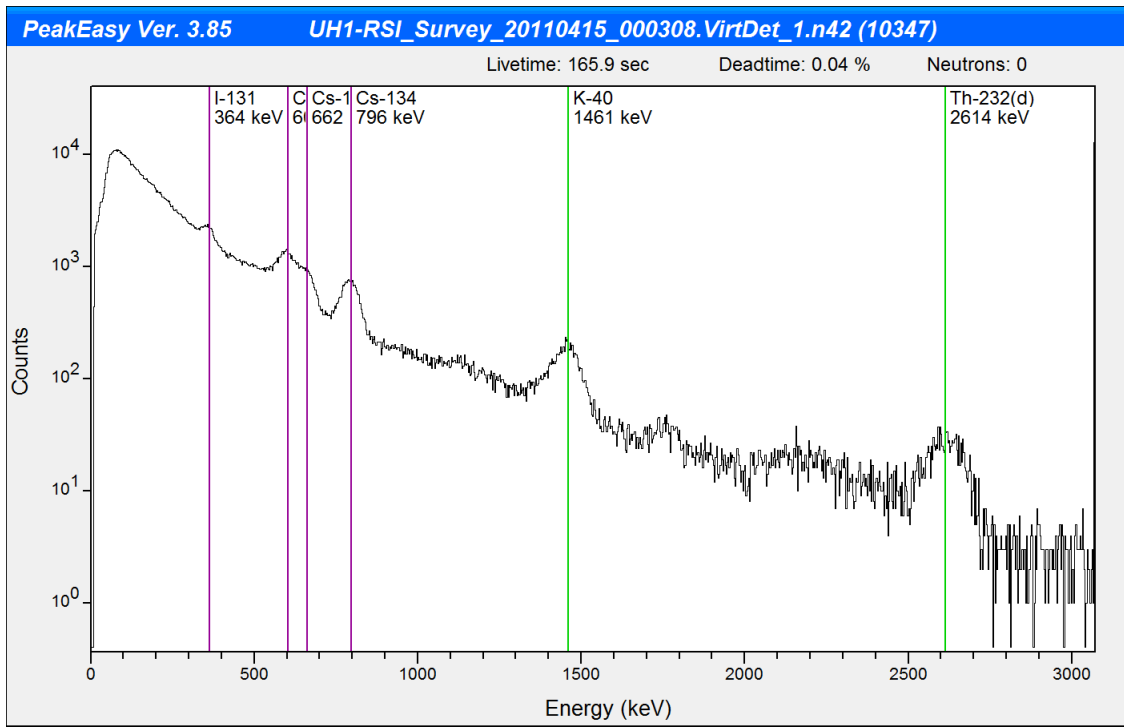
Gamma-Spec Isotopic Extraction

$$Cs-137(3win) = \sum_{E=596}^{728} S(E) - k * \left[\sum_{E=530}^{596} S(E) + \sum_{E=728}^{794} S(E) \right]$$

$$k = \sum_{E=596}^{728} S_{ref}(E) / \left[\sum_{E=530}^{596} S_{ref}(E) + \sum_{E=728}^{794} S_{ref}(E) \right]$$

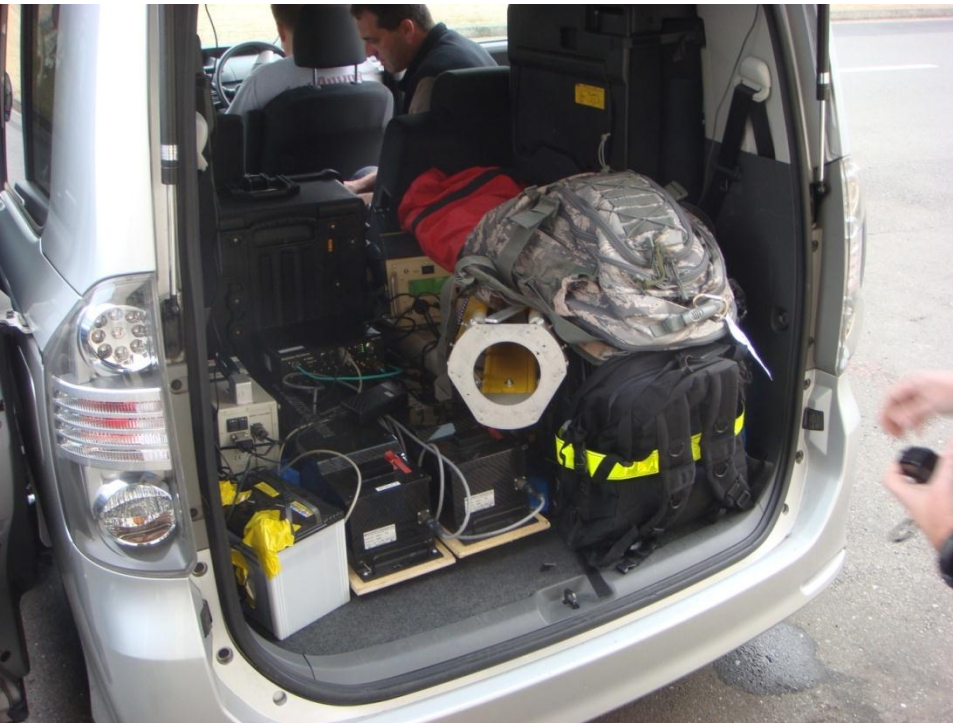
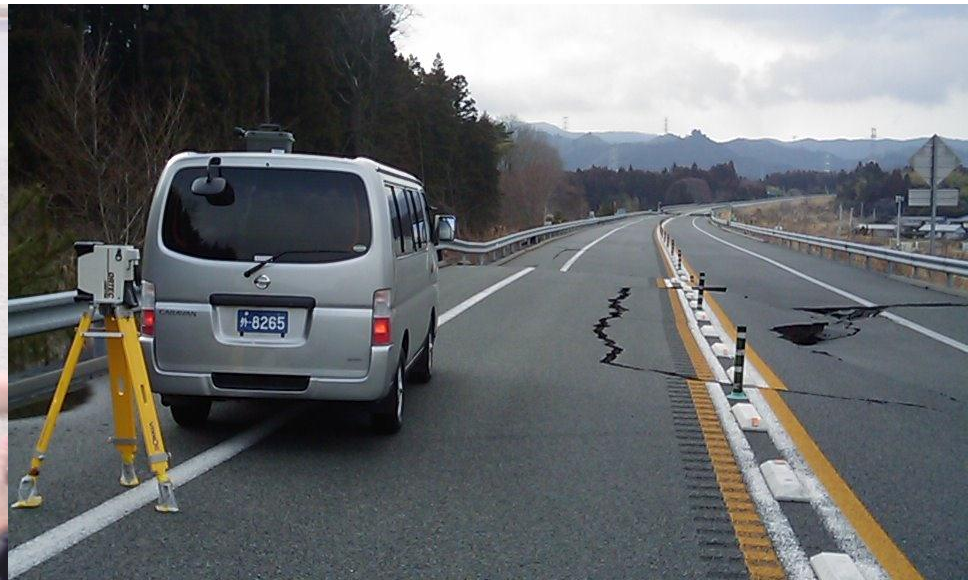
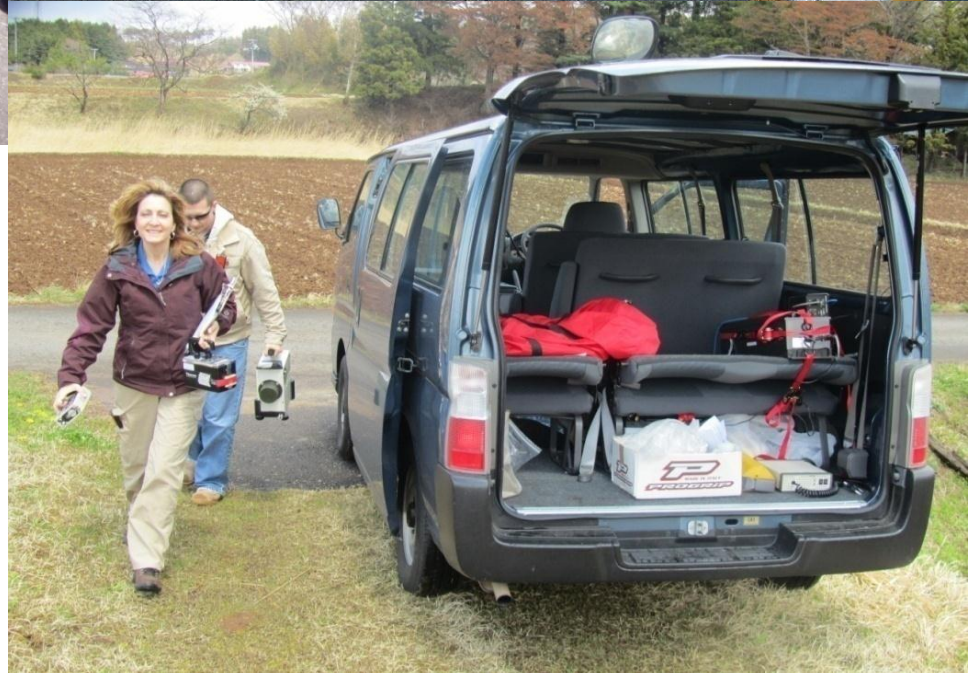
- Mobile monitoring
- In-situ measurements
- Exposure rate measurements
- Air sampling
- Soil samples/core samples
- Swipes

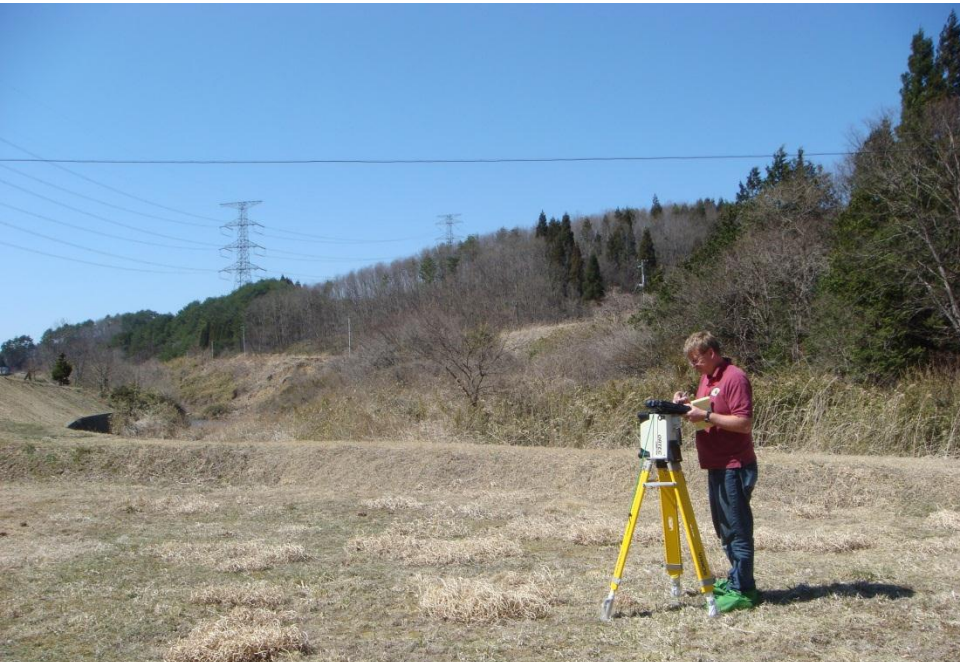
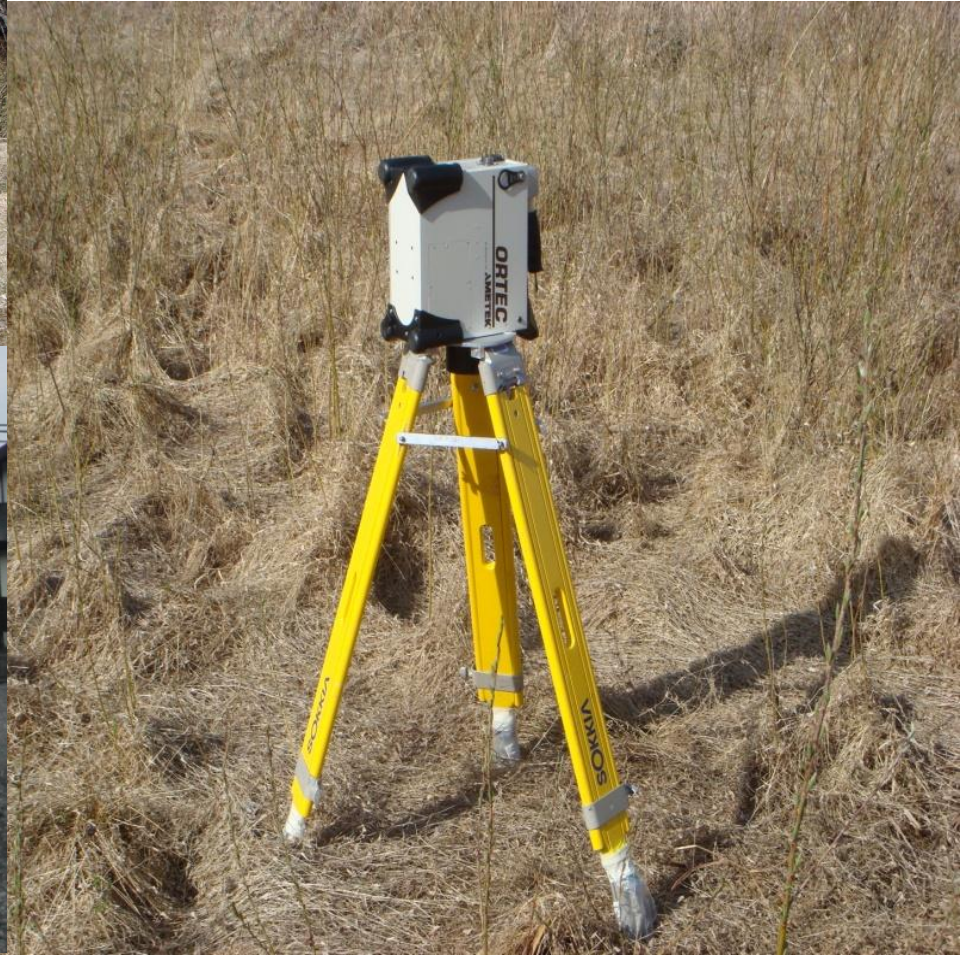
ENERGY *In Situ* HPGe Measurements

- Mechanically cooled HPGe
- 15% Relative Efficiency p-type
- 1 meter above surface

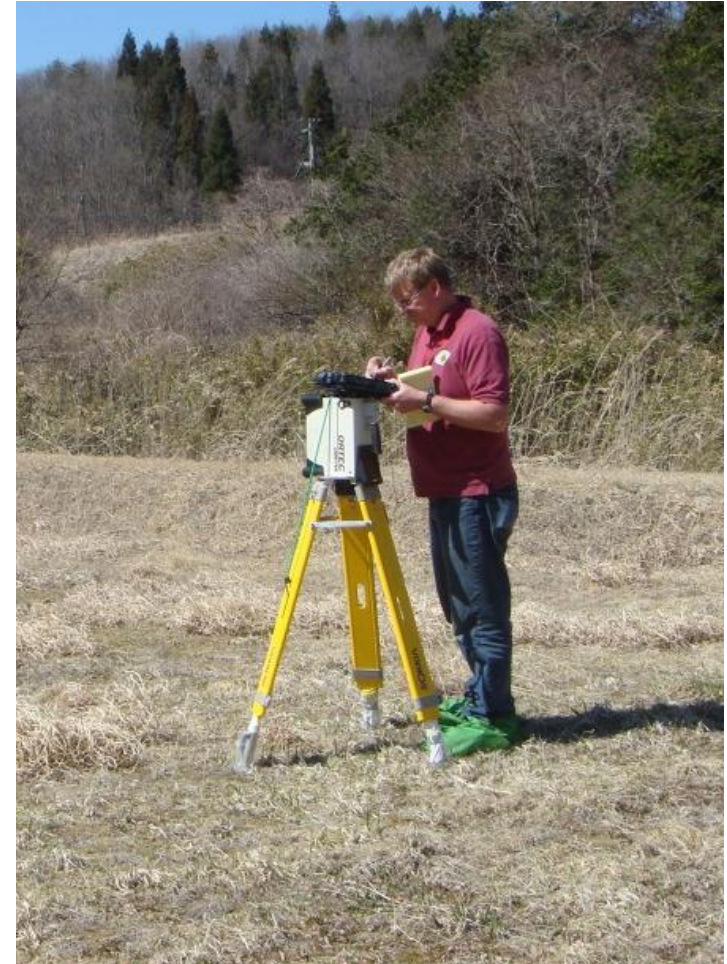
- Infinite plane, uniform deposition assumption
 - Surface roughness
 - Nearby obstructions
 - Deposition on grass and vegetation
- Surface deposition vs. permeation into ground
 - Exponential or uniform depth profile
 - Attenuation through ground
 - Soil and core samples
- Angular response of detector
 - Calibrated pads
 - Point source characterizations
 - Mathematical models (MCNP)

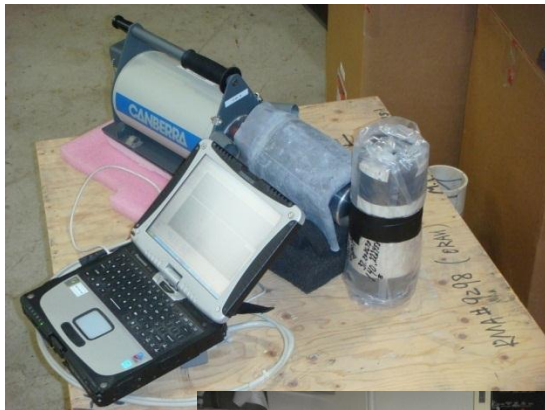
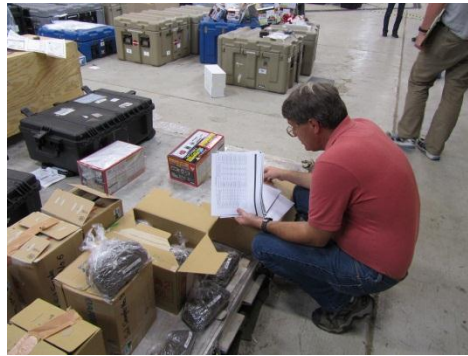
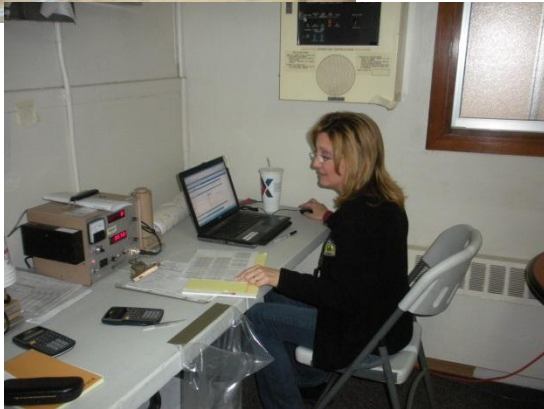
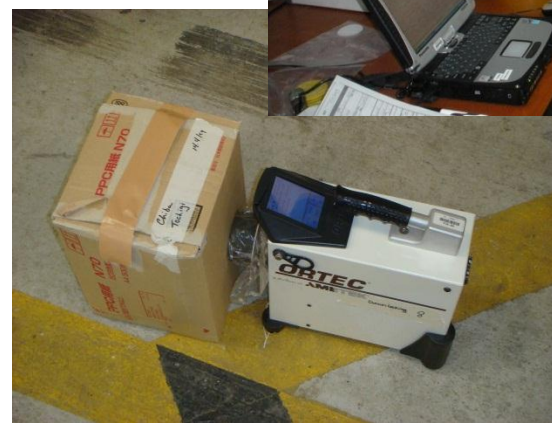
Sample Counting in Contaminated Environment

- Air filter, swipe, and soil samples
 - Lines from I-131, Cs-134, Cs-137 present in background spectra
 - Background varied significantly in early days

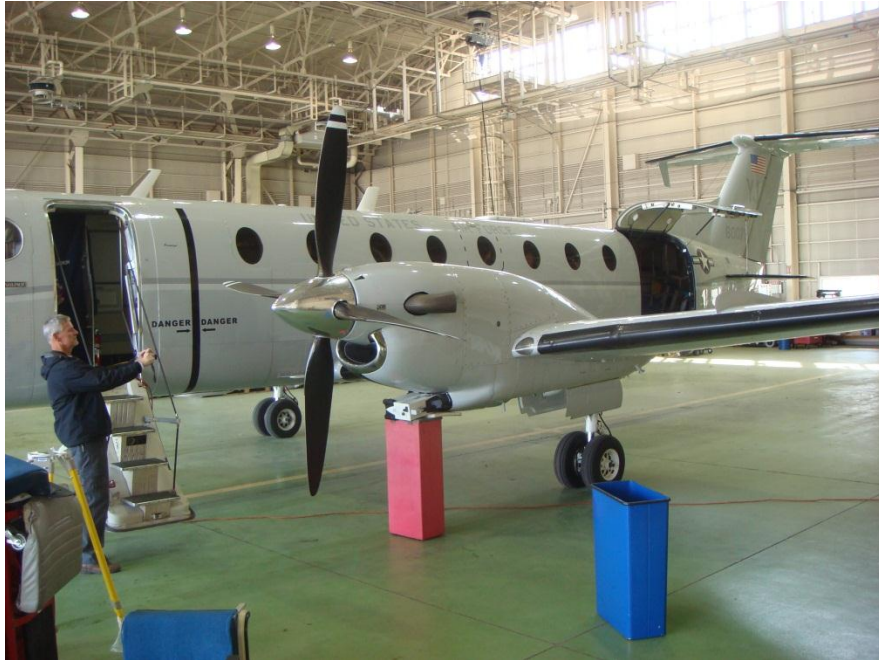
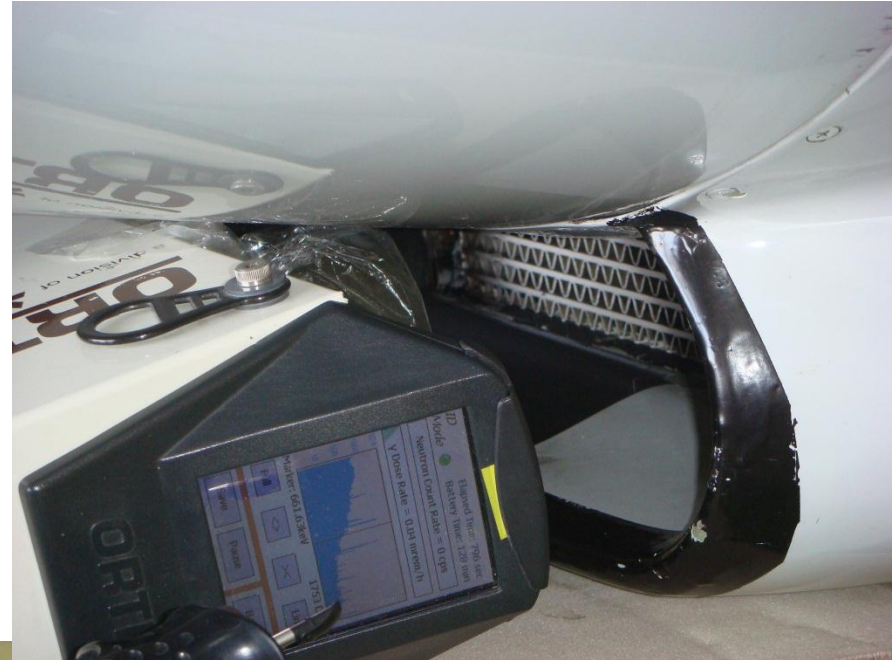
USAF Oil-Cooler NDA Request

- Flight from Okinawa to Yokota
- Concern for ground crew safety
- Request for isotope ID and activity
